Construction Issues

Alabama Seminar
2013

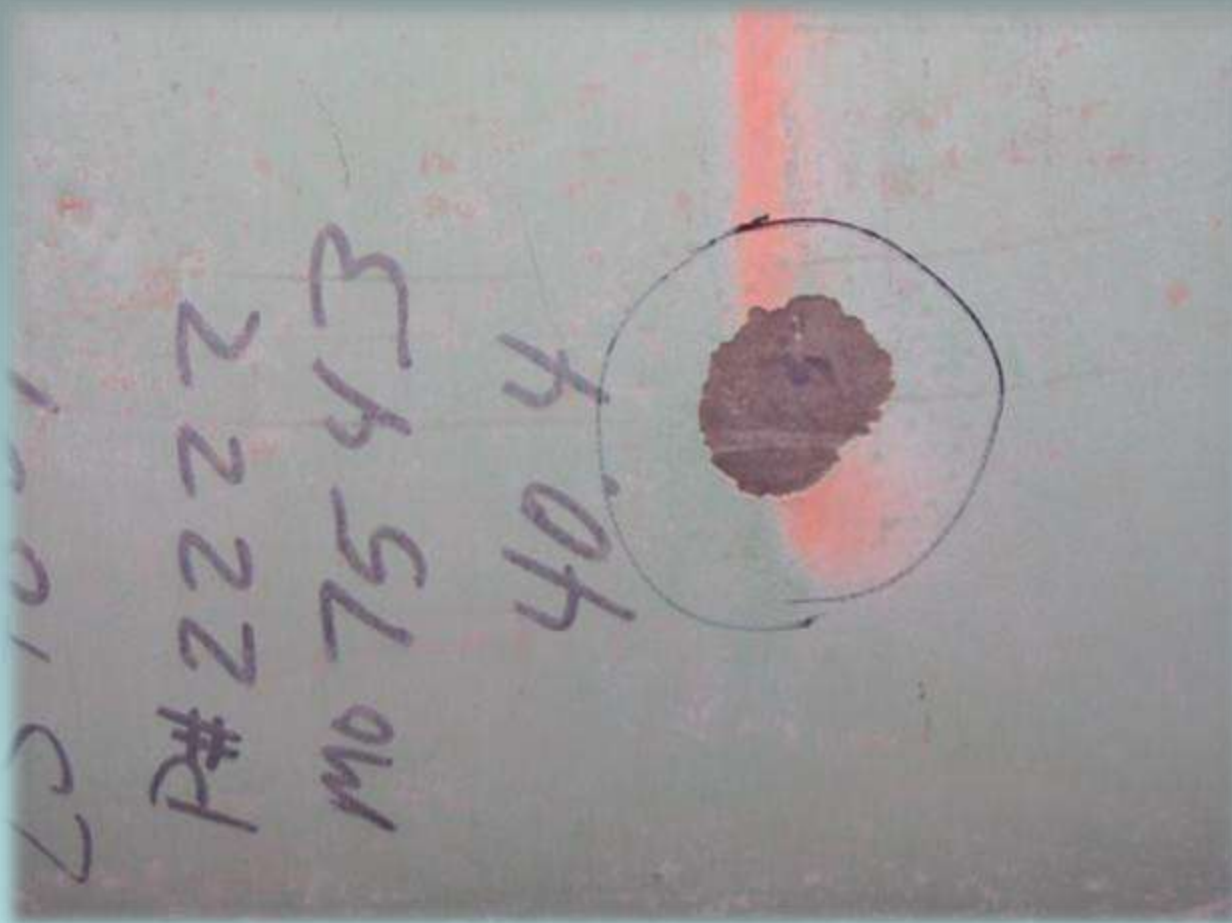
DCVG Dig

Flow → 1-14-09
JB DCVG-15 42" 0.486w X 80"
Lat: 40.8946703 014-001-00-00
Long: -101.9936483
Called out as 11.67% Jeep setting: 1.7 KV
DCVG Distance: 7974+47
UT: 0.491" TEMP: 75°
Coating Thickness: 14 mils
15 total Holidays in 10' of pipe
ranging from 1/4" x 1/4" to pinholes

15 Holidays

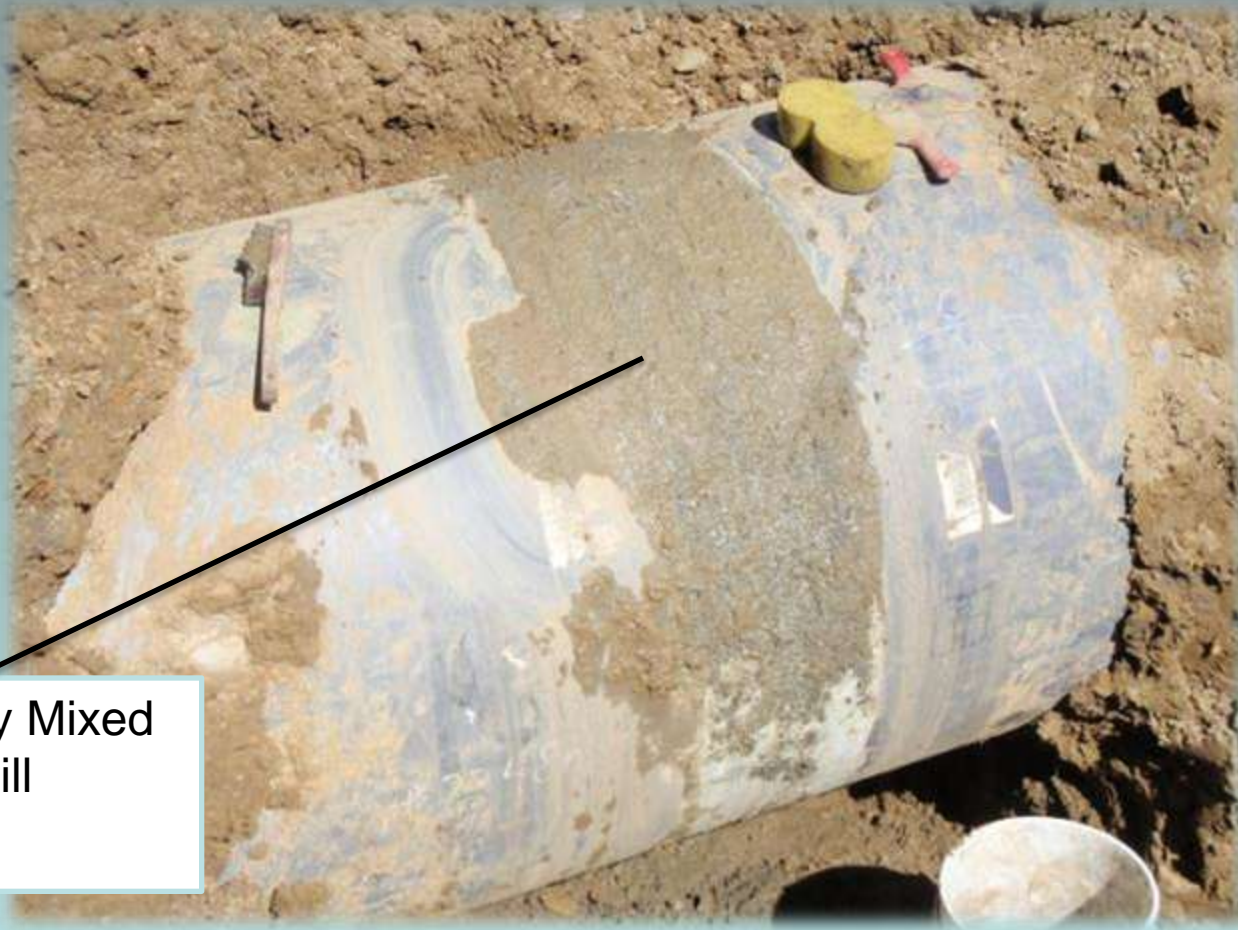
DCVG Dig on First Phase – Girth Weld Coating Mixed with Backfill

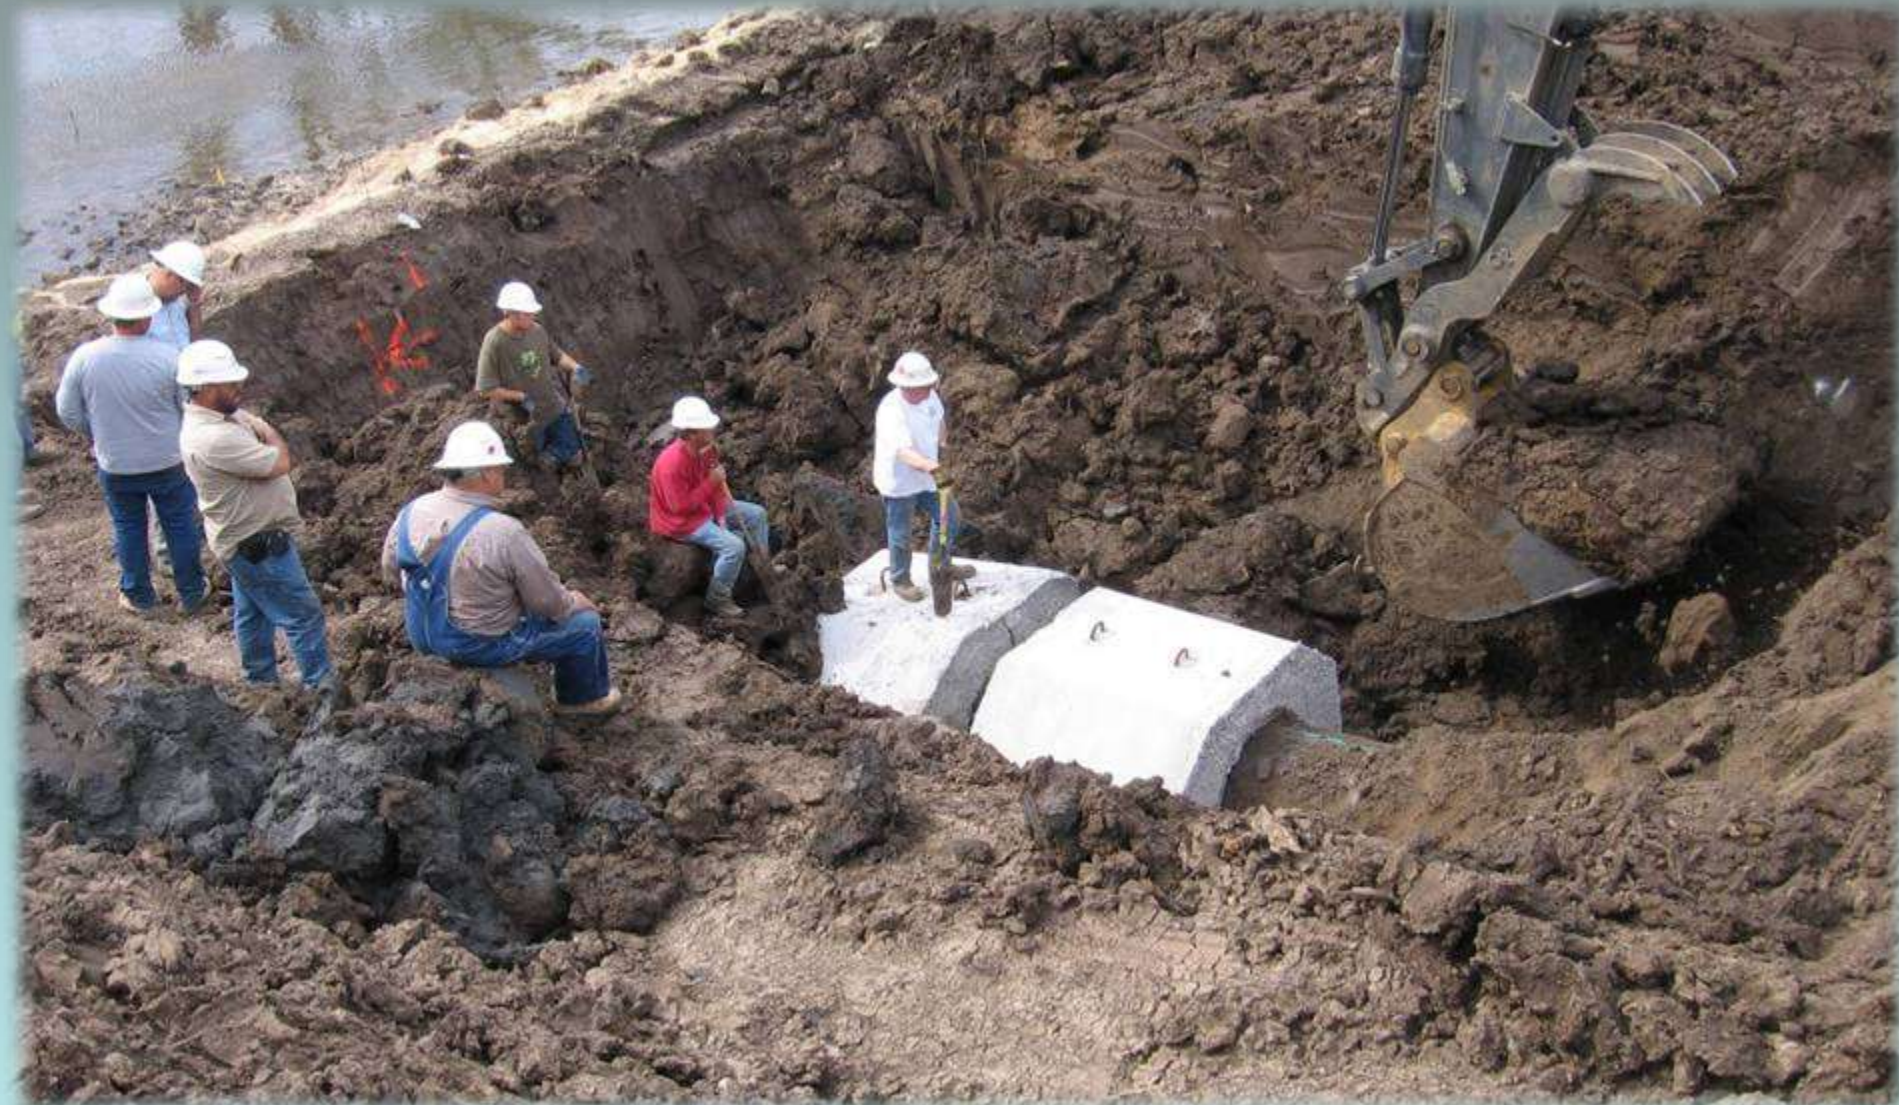
Are there sufficient weights?

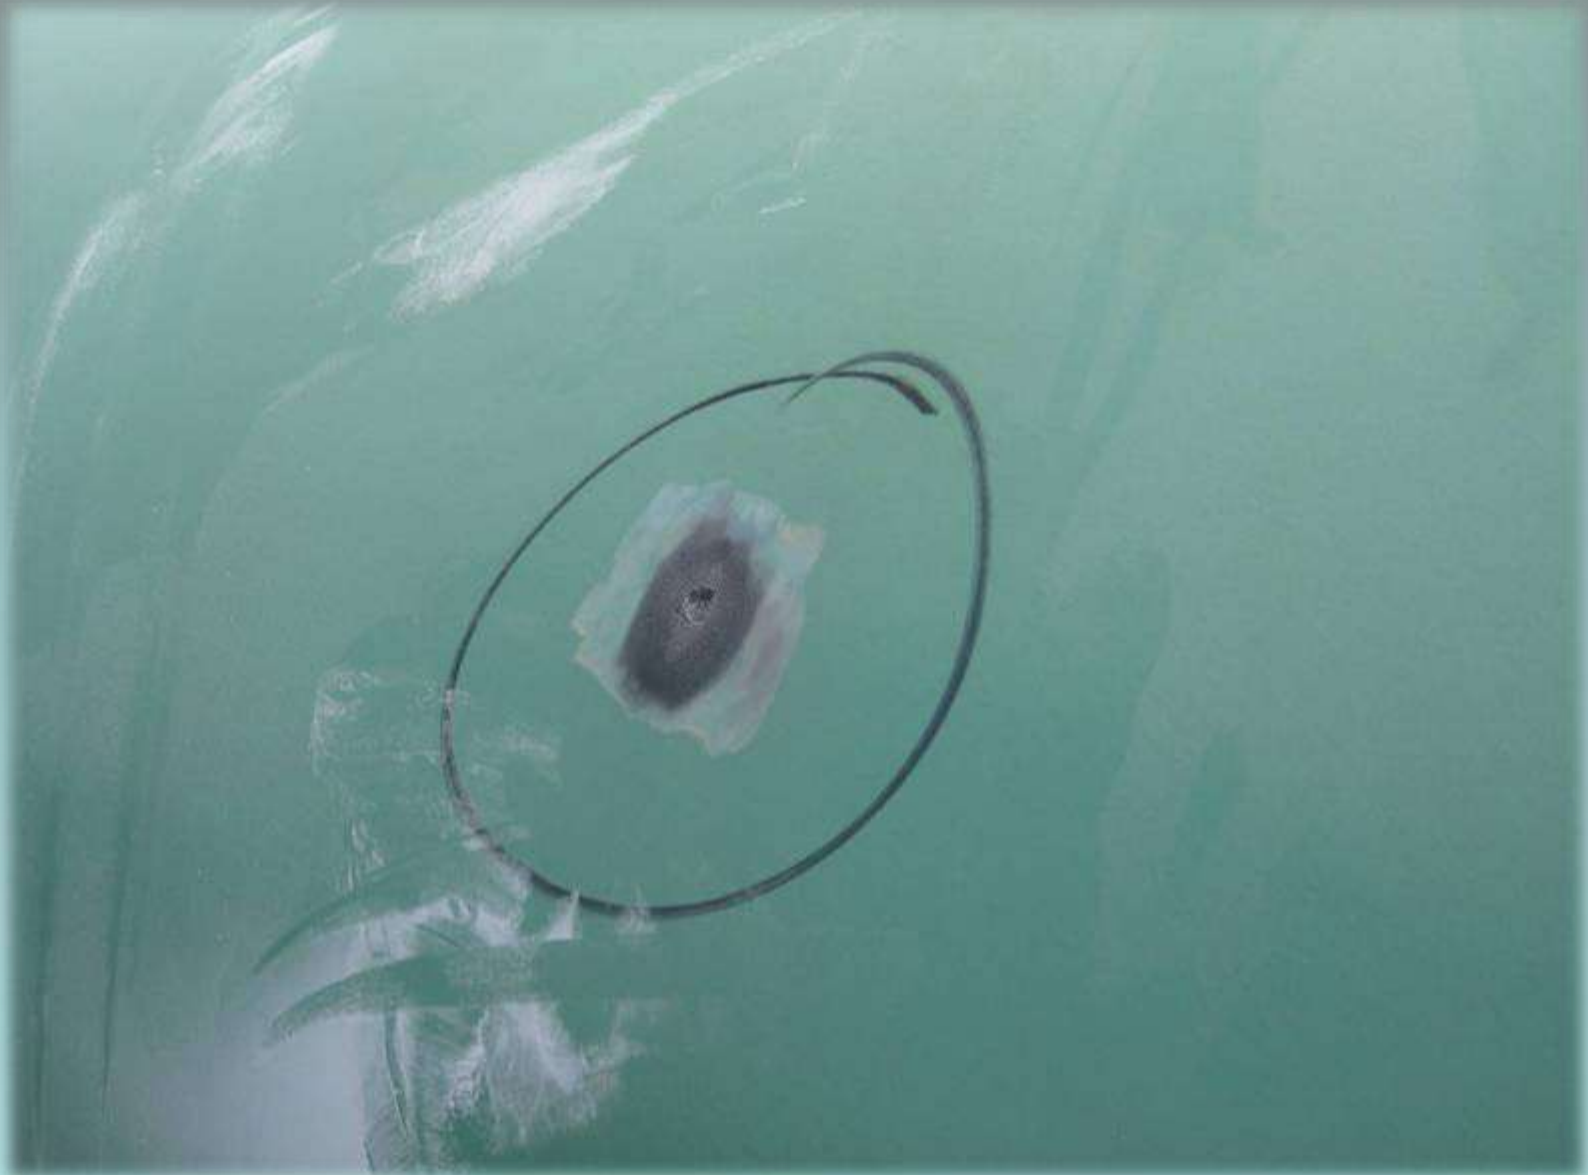
Pipe Defect – Does remaining wall thickness meet requirements of API 5L?

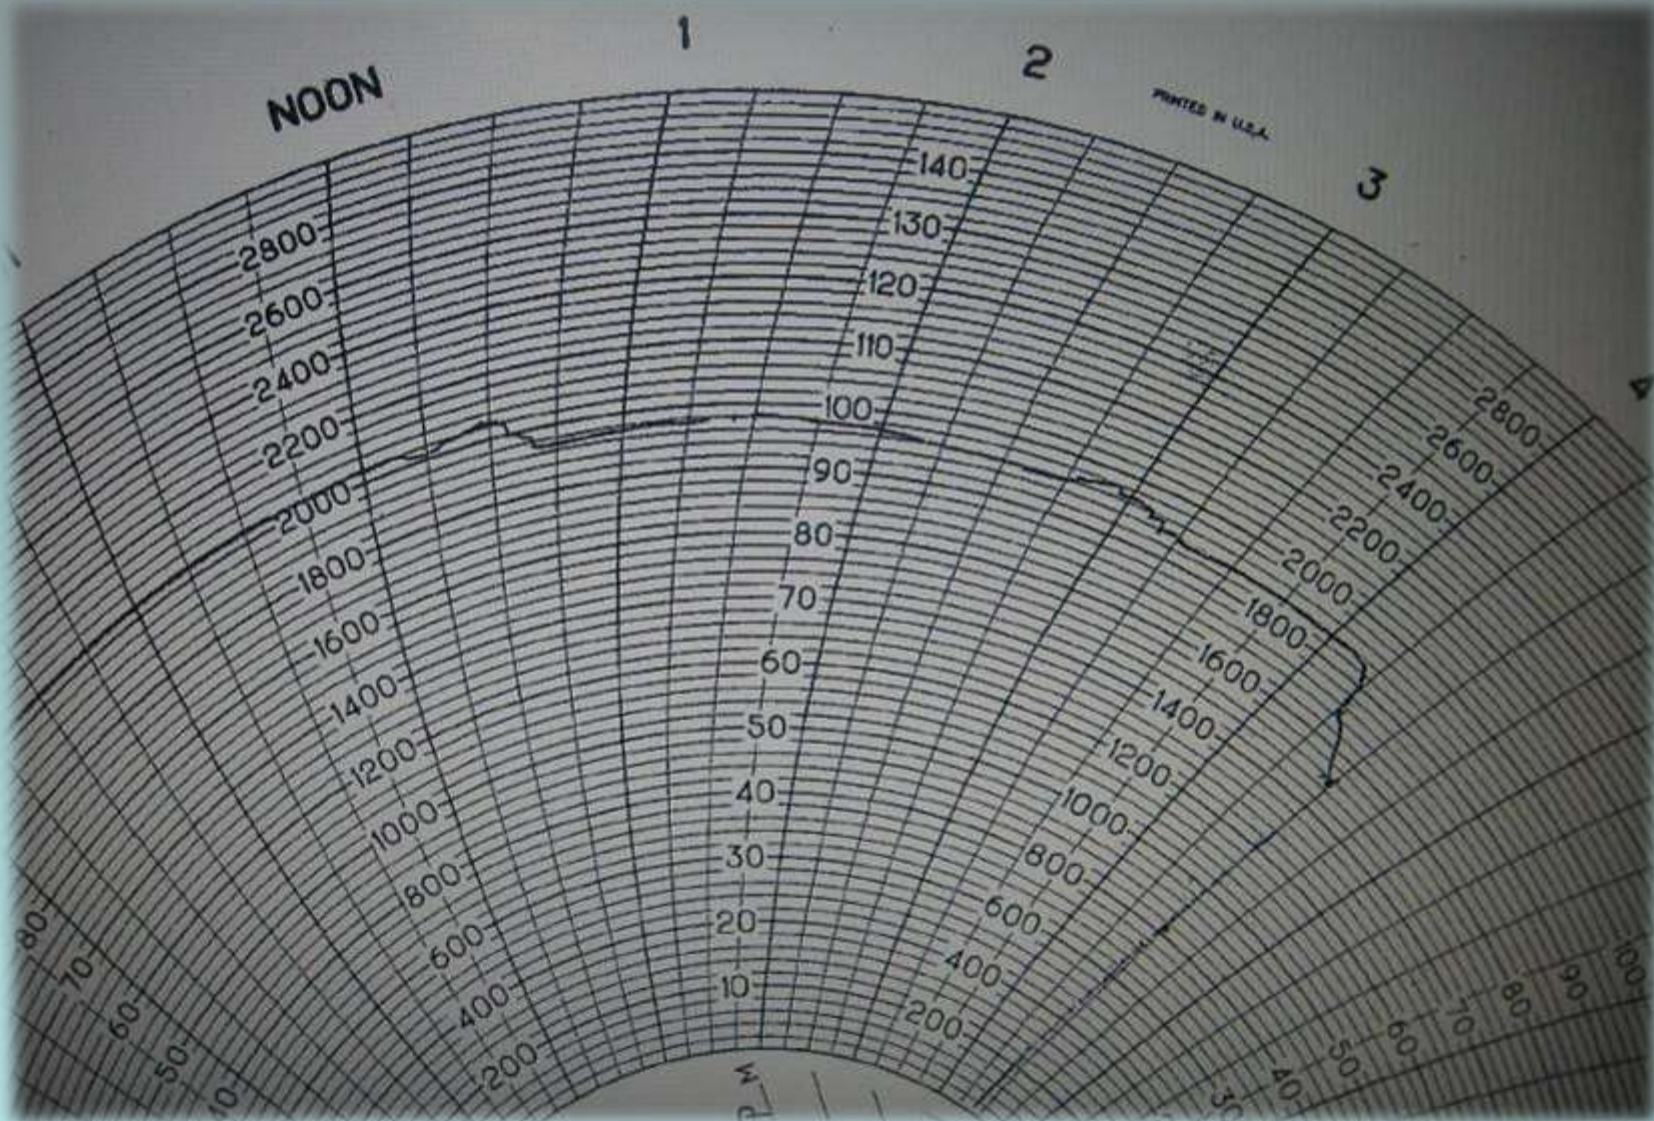
Chart shows pressure loss last 3 ½ hours

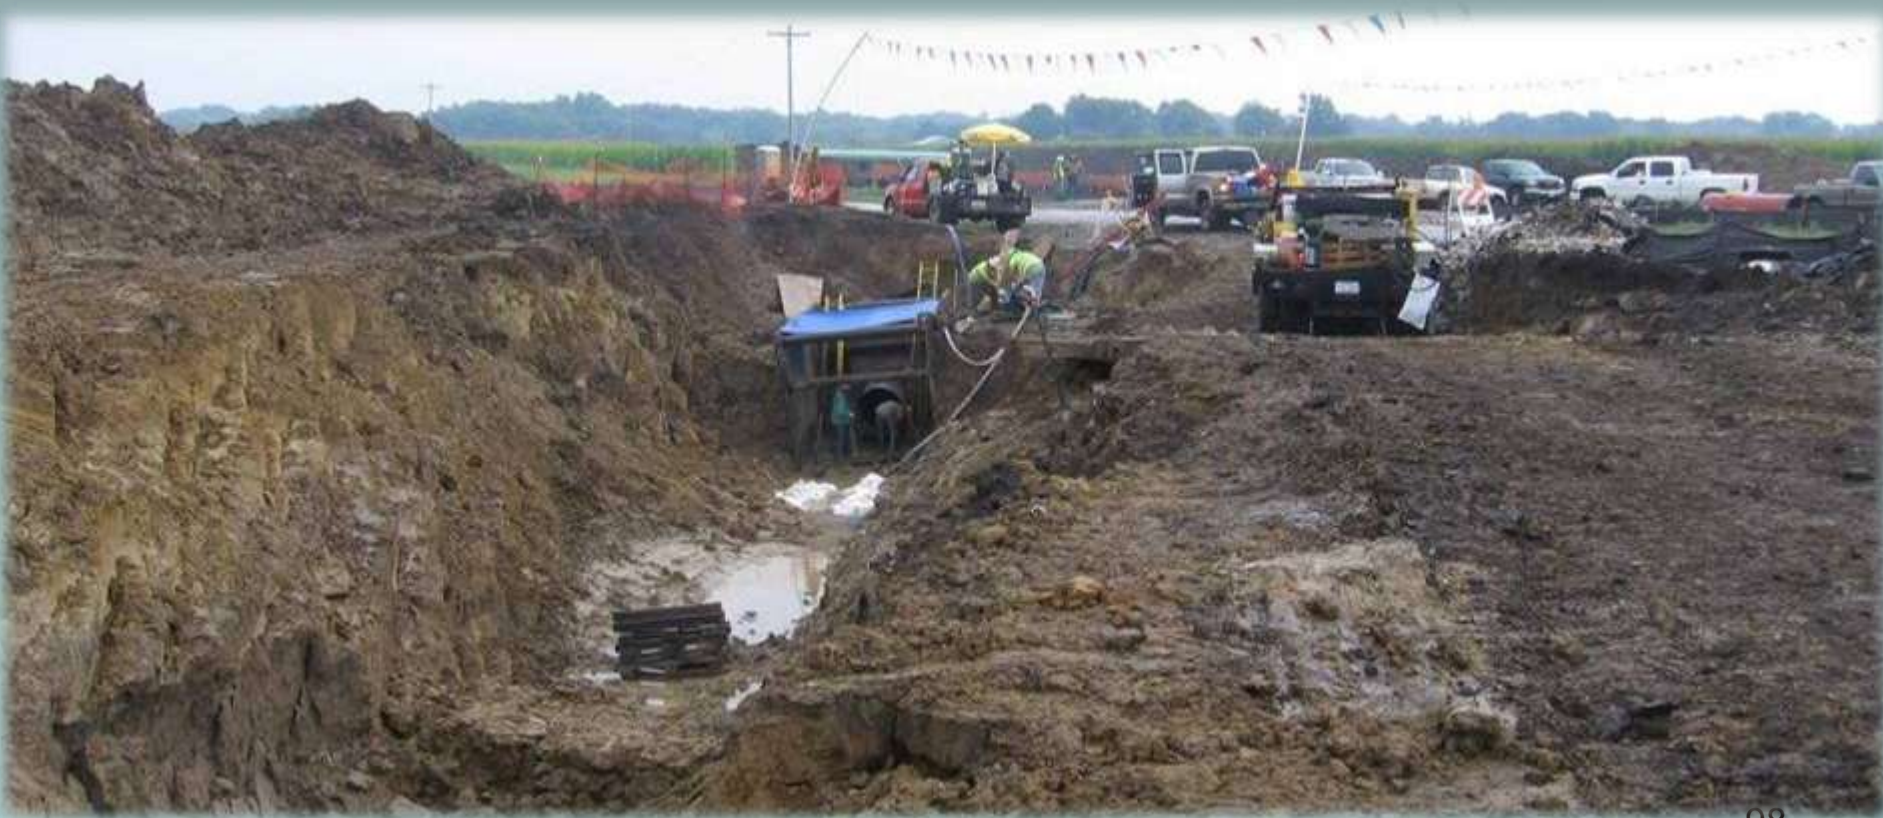
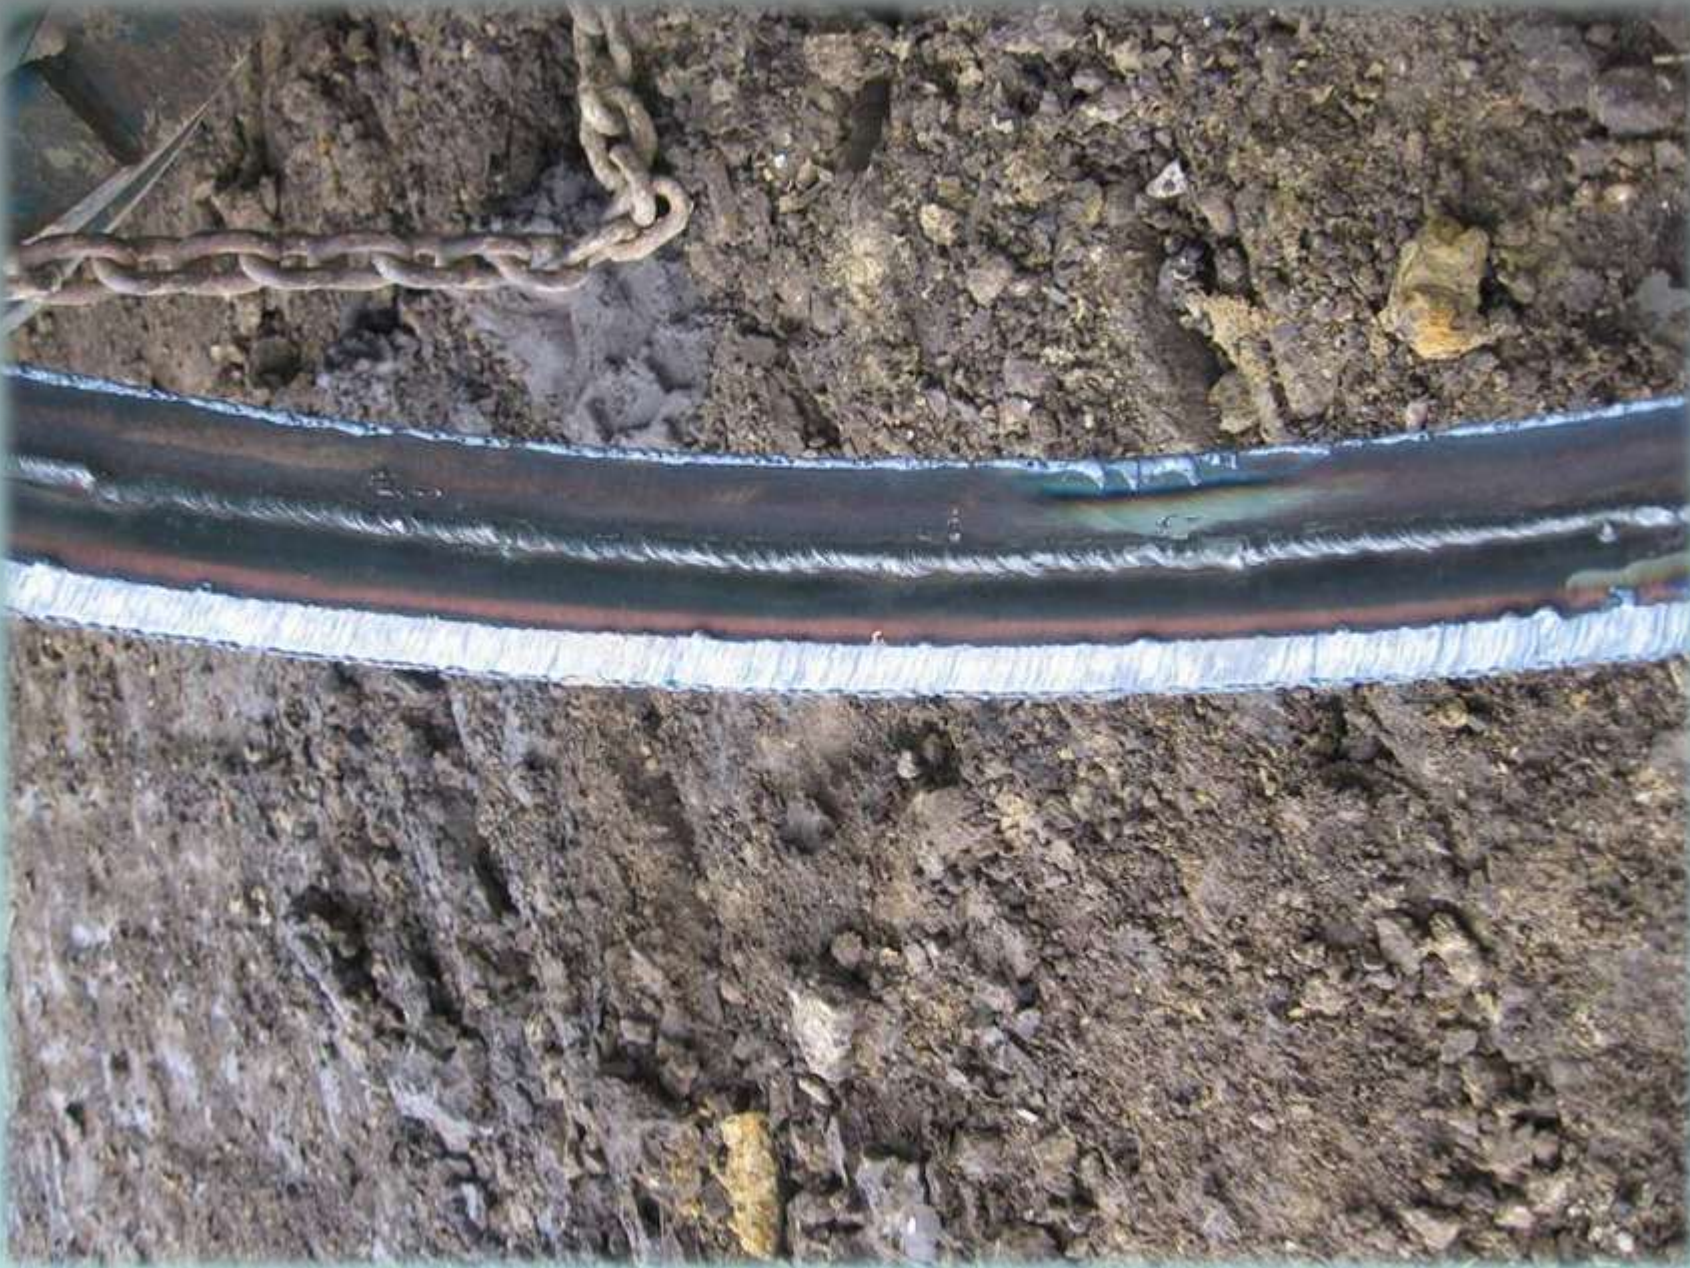
The external weld was completed in the trench box. Then the welder crawled inside and completed the back weld. This was a transition weld between 0.740 and 0.486 wall thickness pipe. The welder struck the arc multiple times inside the pipe and missed the bevel multiple times.
